Manhole Inspection Summary

Manhole # S31WW1015MH

Location Address: **105 TURNBRIDGE RD**

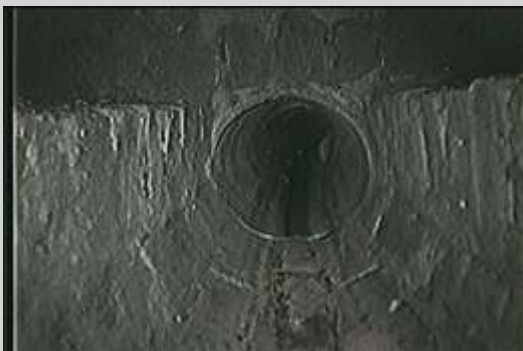
8 in. Circular Gravity Sewer Pipe In @ 6 O'Clock

Rod and Bar (Angled)

Infiltration: **None** Pipe Seal Cond: **Unknown**
